United Pacific

HIGH POWER LED DUAL HEADLIGHT

Item Numbers: 32141, 32143, 32144, 32783, 32784, 32785, 32786

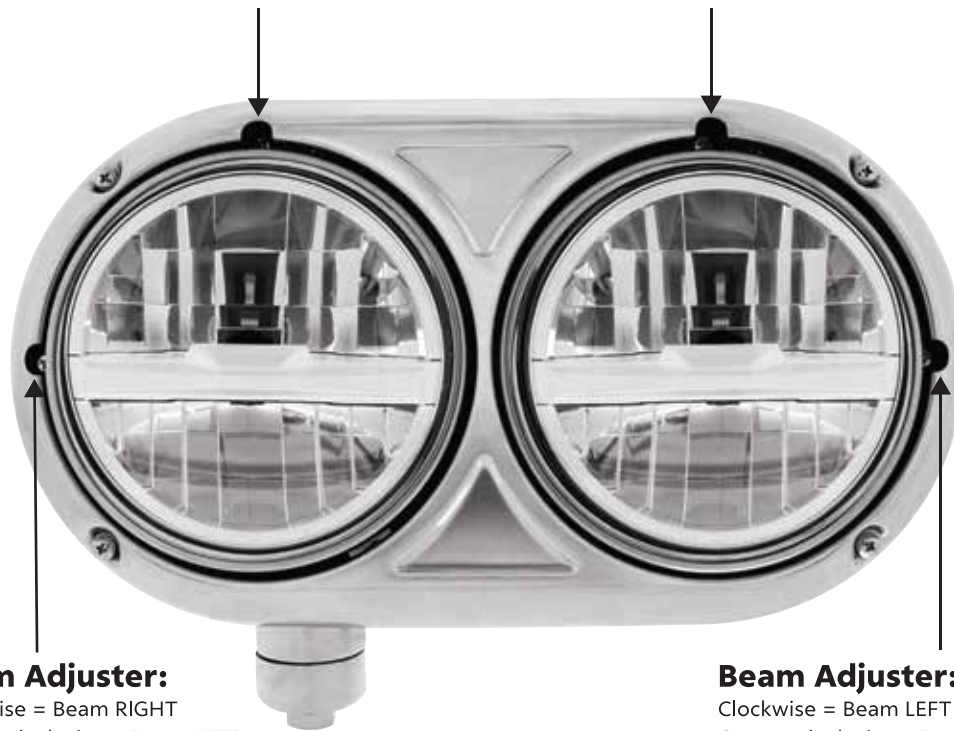
Beam Adjuster:

Clockwise = Beam UP
Counterclockwise = Beam DOWN

Clockwise = Beam RIGHT
Counterclockwise = Beam LEFT

Clockwise = Beam LEFT
Counterclockwise = Beam RIGHT
