United Pacific

# PROJECTION HEADLIGHT

Item #31286, 31287, 31270, 31271, \*31226, \*31227, \*31228, \*31229

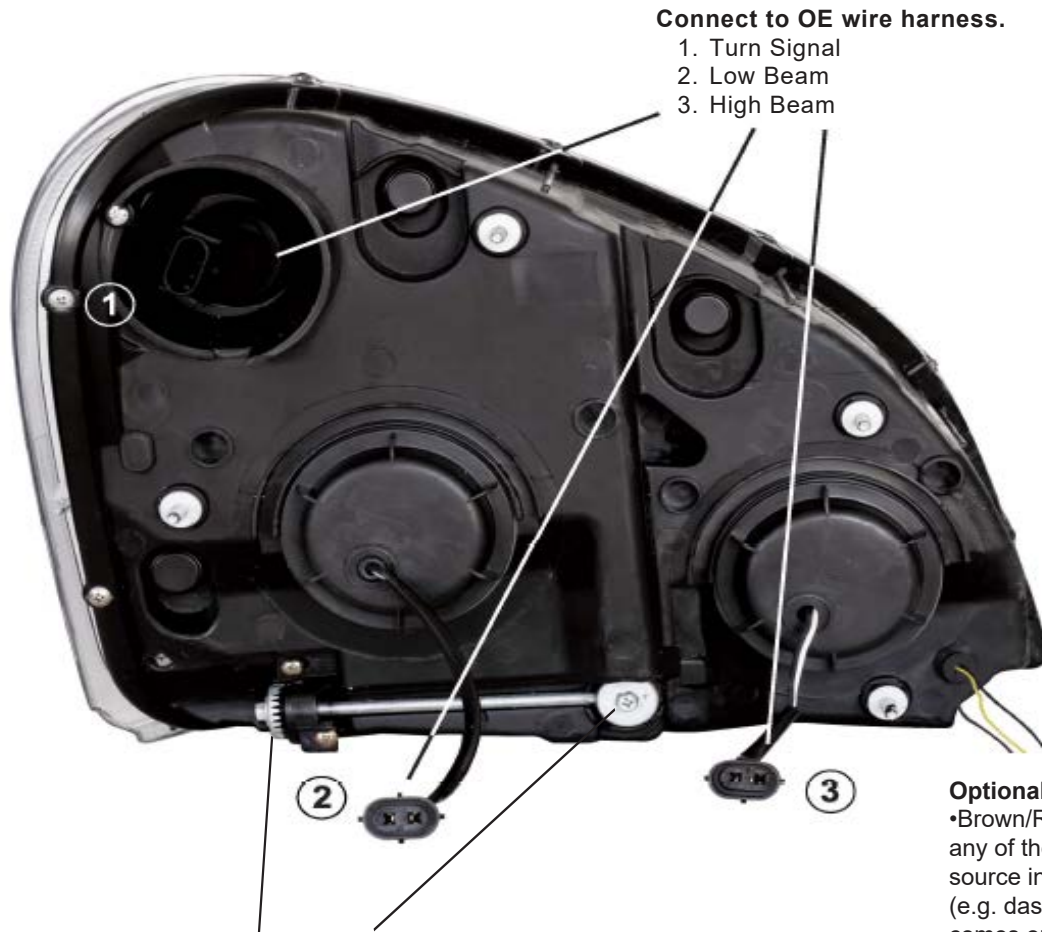
Connect to OE wire harness.

1. Turn Signal
2. Low Beam
3. High Beam

## High/Low Beam Adjuster:

Clockwise = Beam DOWN  
Counter clockwise = Beam UP

•Brown/Red Wire - Positive wire (dual function version's Low function), must NOT be hooked into any of the OE harnesses. It is recommended this Brown Positive Wire be hooked to a 12v + source independent of the OE light harnesses. Locate a power wire which activates an accessory (e.g. dash auxiliary) when the ignition is in the "ON" position, so that the LED position light only comes on when the truck ignition is "ON" and running.

•\*Yellow Wire - Positive wire (dual function version's High function). Can be use as turn signal, simply tap into truck's signal turn power wire.

Black Wire - Ground, connects to body of the truck.
